## RTA BUS GARAGE

### Installation

2009

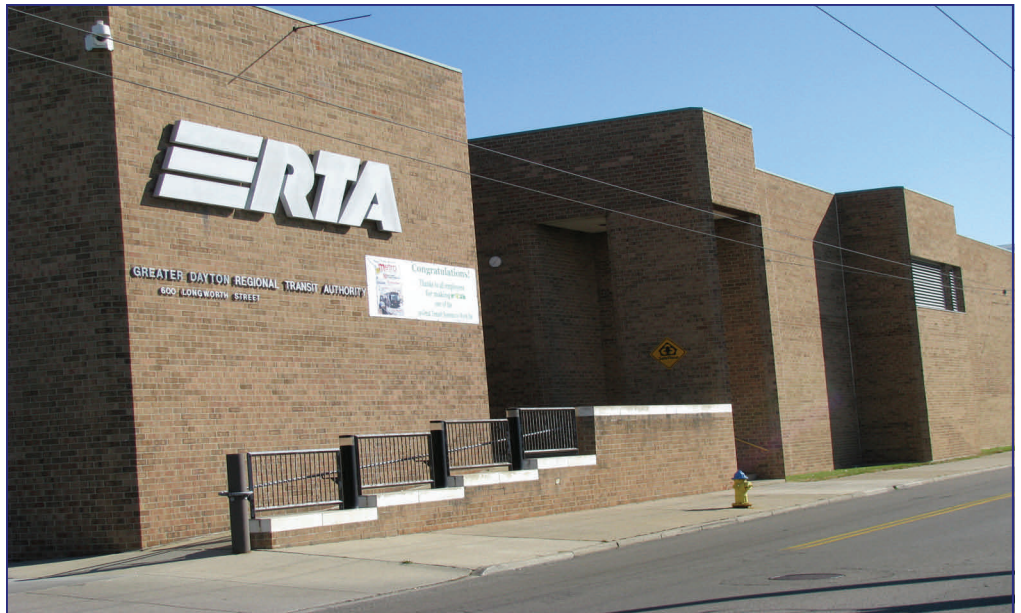
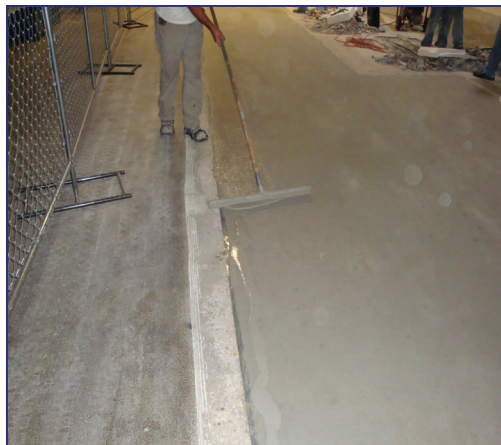
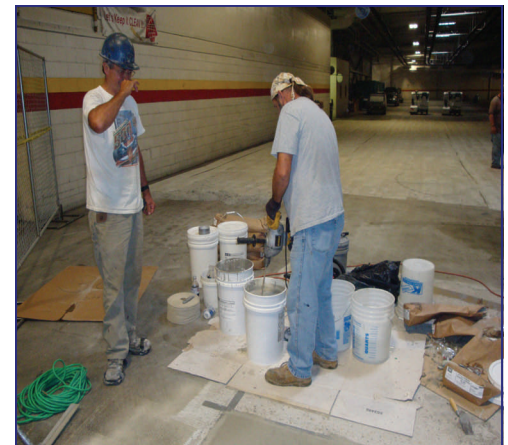
After reviewing their options, the Owners selected Strongcote SC-113 vehicular traffic coating to coat the 80,000 sq. ft. of this bus garage. After extensive tendon repairs were made to this post tensioned deck, as well as considerable concrete repairs, the entire surface was coated with three coats of SC-113.
